# Manhole Inspection Summary

Manhole # S43UU\_030MH

Insp Date: **2/9/07 1:14 PM**

**Location** Address: **2710 KENNEDY AVE**

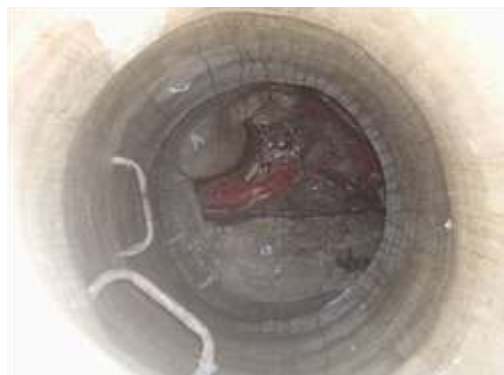
Top View

Corbel infiltration. Bench debris.

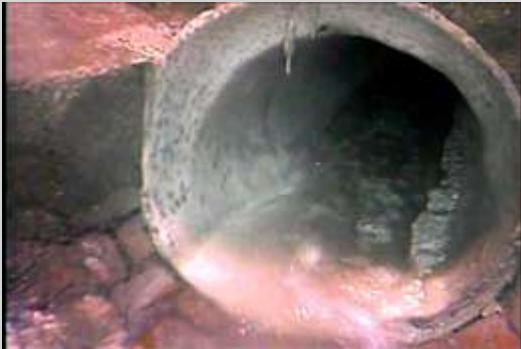
### 14 in. Circular Gravity Sewer Pipe Out @ 12 O'Clock

Deposits: ☐ None ☐ Mud ☐ Sludge ☐ Debris ☒ Grease

Silt Depth: **0** (in.) Deposits Extent: **Light**
